# Manhole Inspection Summary

Manhole # S31O\_\_001MH

Insp Date: **12/29/08 9:30 AM**

**Location** Address: **600 W Hamburg St**

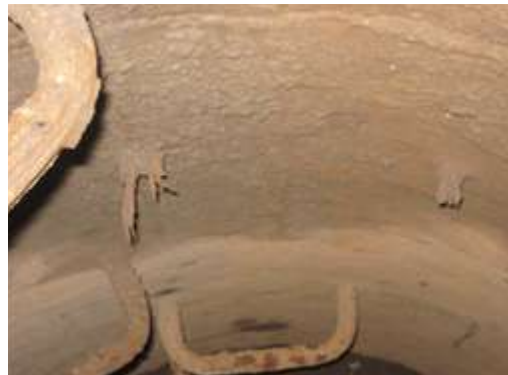
Defect 4

Count: **5** Missing: **1** ☒ **Corroded**

steps corroded and missing

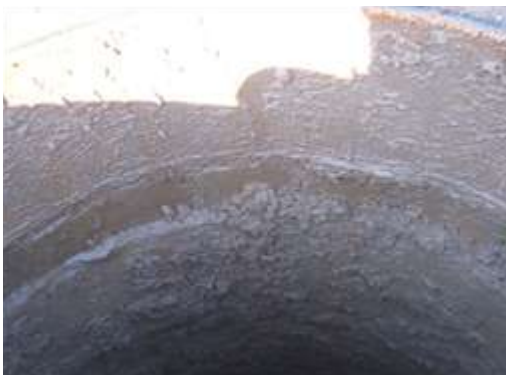
Defect 3

☒ **Leaks**

frame infiltration at cover

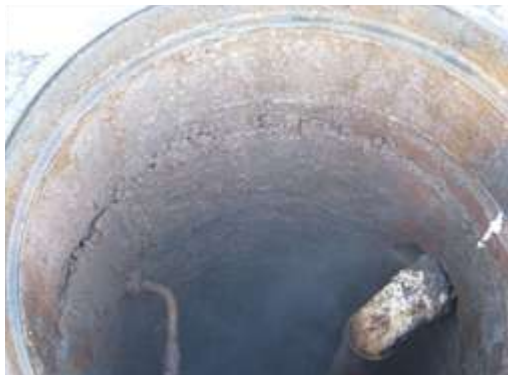
### Defect 1

Infiltration: ☐ None ☒ **Joint** ☐ Cracks ☐ Mortar ☐ Roots ☒ **Wall**

corbel infiltration at wall and chimney joint
